Case Study: Pigging for Pipe Anomalies

The Challenge

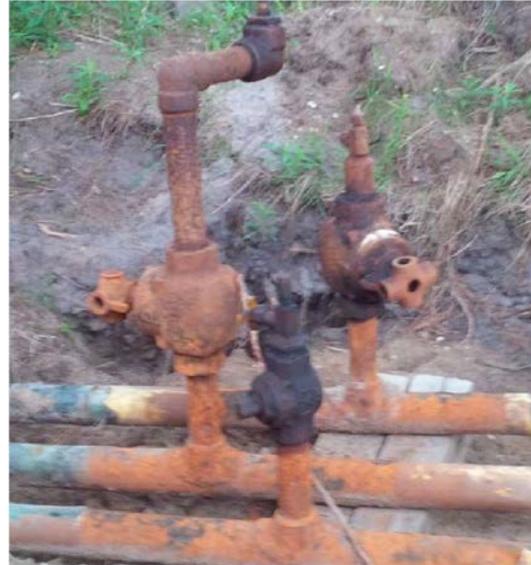
Figure 1 Valves Targeted for Repair

An old, small piping line extending over 6 miles needed to have all of the valves inspected, and, where necessary, repaired or replaced. A sample of the target problem valves is shown in Figure 1. But with the piping buried several feet deep, and no map identifying the location of these valves, the repair team needed a way to identify where to dig. Smart pigs were made for much larger pipe diameters than those in question, so the team came to TECAT for a small, smart pig solution.

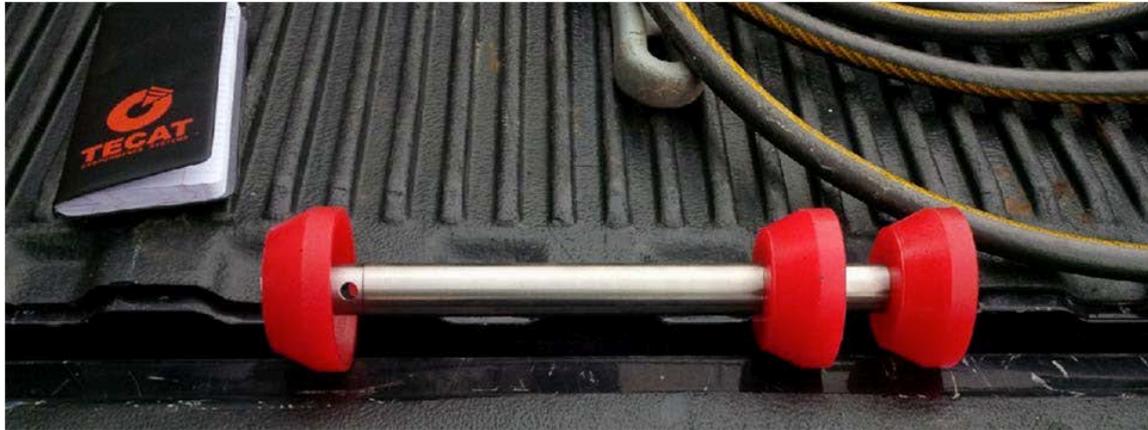
Figure 2 TECAT's Smart Pig

TECAT engineers adapted a small sensor system comprised of an inclinometer, an accelerometer and a magnetometer, for mounting onto a small pigging device. The pig, shown in Figure 2, was launched through the pipeline, and recorded data along the path of the pipe. After the pig was retrieved, the data was downloaded for analysis. The team was able to identify every anomaly found along the pipeline by examining all three data parameters collected, as shown in Figure 3. Based on magnetic spikes, acceleration spikes, and the location in the pipeline, the team compiled a list of possible valve locations, along with a probability ranking for each anomaly detected. A large spike in both

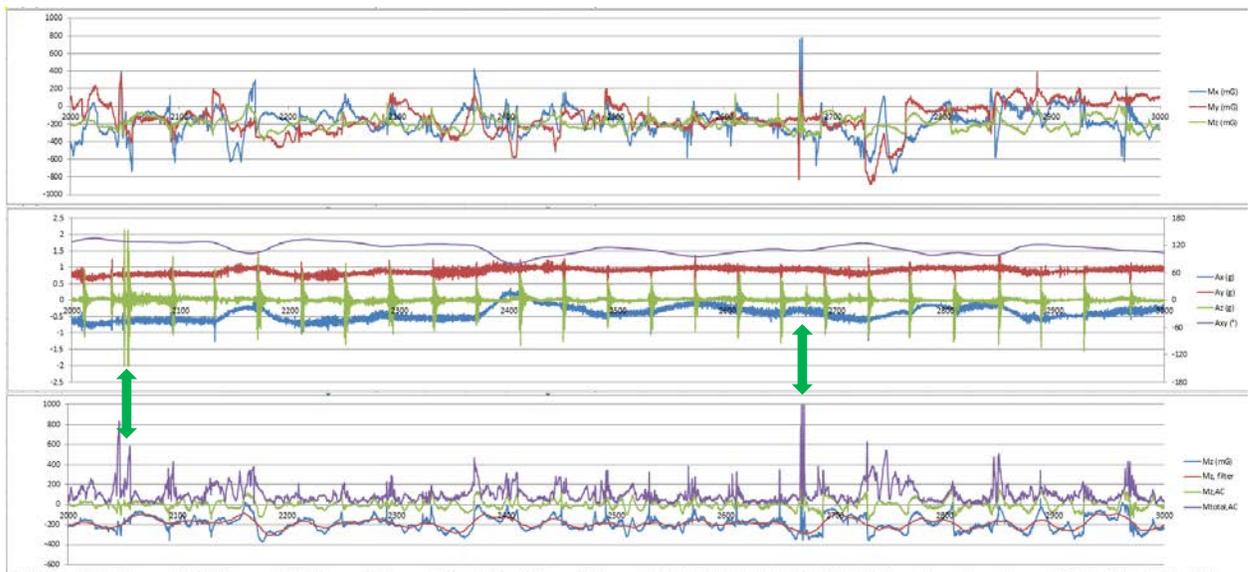
Figure 3 Examination of Three Datasets Simultaneously Provided Strong Correlation to Dig Locations

magnetometer reading and acceleration reading typically indicated a valve, which was verified upon digging at the identified location. The system was found to be very sensitive, with anomalies detected due to bare welds, double welds, and bare pipe. Each of these was still of benefit, as these sections were also fixed, and wrapped when necessary.
